**Flood Control Project Maintenance
Levee Inspections**

Maintenance Issue Types Only, Levee Inspection Report By Mile - Fall 2018

Lake County Watershed Protection District

Waterway	Bank	Unit Miles	Inspection Start/End	Inspector
Unit No. 01 Middle Creek	Left	3.35	09/26/2018 09/26/2018	Bob Duffey

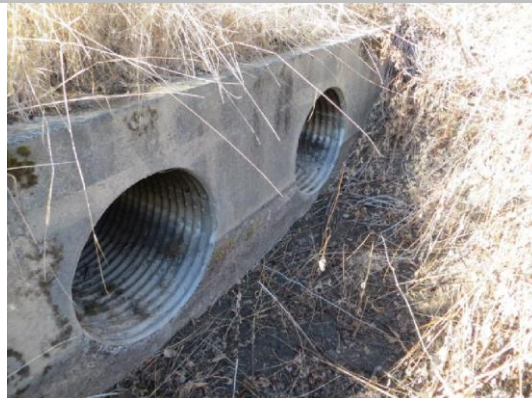
Photo 2 of 3 : UCIP_FA_2018_26986_49848.jpg

Concrete headwall and pipe visible on LS toe.

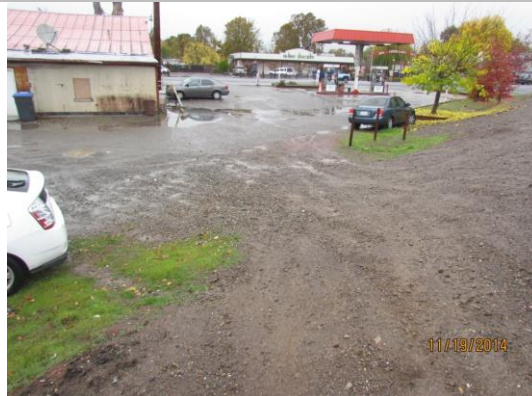
Photo 1 of 1 : FA_2018_NA0009_3_17_20180905_00011.jpg

View of the erosion caused by vehicle along the landside slope.

LM Start	2.42	Rating **	M	Issue No.	17
LM End	2.42	Issue Type +	Ma	Location *	LS
Category	Earthen Levee			GPS Latitude/Longitude	
				Start	End
Item	Slope Stability			39.161802°	39.161802°
				-122.912020°	-122.912020°
DWR ID	DWR_NA0009_01_s_2013_17				
Comment Code					
S3 : Repair the levee slope damaged by vehicle traffic and prevent access where possible.					
Inspector Comment

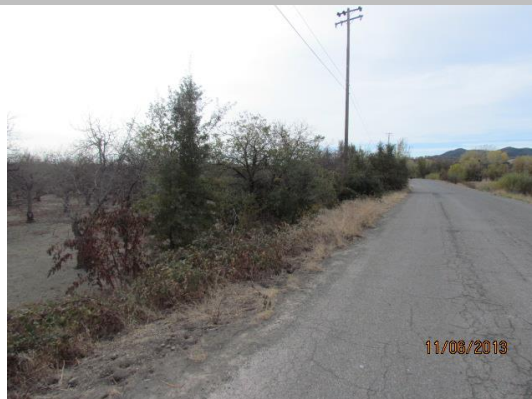
Photo 1 of 2 : FA_2018_NA0009_3_3_20180905_00001.jpg

View of the vegetation along the landside slope.

LM Start	2.48	Rating **	U	Issue No.	3
LM End	2.55	Issue Type +	Ma	Location *	LS
Category	Earthen Levee			GPS Latitude/Longitude	
				Start	End
Item	Vegetation			39.161615 °	39.160804 °
				-122.911733 °	-122.912536 °
DWR ID	DWR_NA0009_01_s_2012_3				
Comment Code					
V2 : Remove the wild growth other than native grasses from the levee slopes.					
Inspector Comment

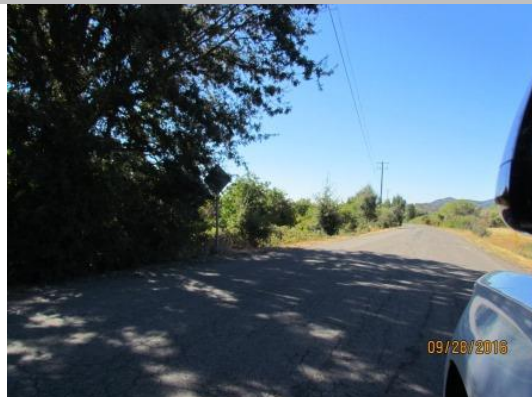
Photo 2 of 2 : FA_2018_NA0009_3_3_20180905_00002.jpg

View of the vegetation along the landside slope.

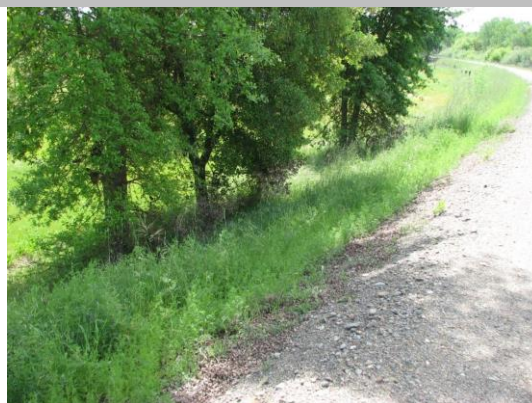
Photo 1 of 1 : FA_2018_NA0009_3_25_20180905_00013.jpg

Trim trees to 5' above levee slope (LS). 4/19/2016

LM Start	2.95	Rating **	M	Issue No.	25
LM End	2.95	Issue Type +	Ma	Location *	LS
Category	Earthen Levee			GPS Latitude/Longitude	
				Start	End
Item	Trim / Thin Trees			39.155301°	39.155301°
				-122.914633°	-122.914633°
DWR ID	DWR_NA0009_01_s_2016_25				
Comment Code					
T1 : Trim trees to at least five feet above ground level.					
Inspector Comment

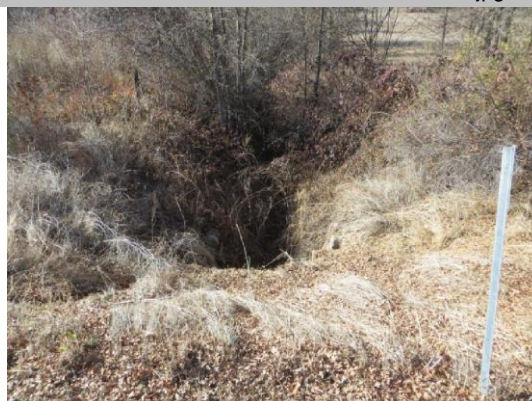
Photo 1 of 3 : UCIP_FA_2018_27066_50049.jpg

Pipe and headwall visible at LS toe in drainage swale.

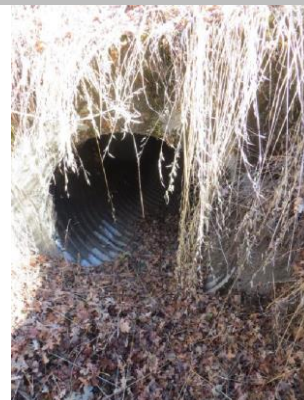
Photo 2 of 3 : UCIP_FA_2018_27066_50048.jpg

Pipe and headwall visible at LS toe in drainage swale.

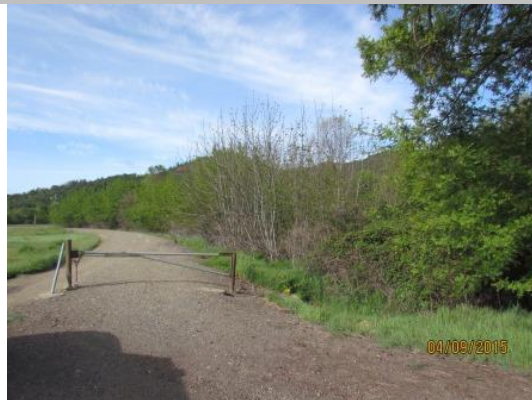
Photo 1 of 1 : FA_2018_NA0009_4_9_20180905_00006.jpg

View of the overgrown trees and vegetation at the landside toe.

LM Start	0.24	Rating **	M	Issue No.	9
LM End	0.27	Issue Type +	Ma	Location *	LS
Category	Earthen Levee			GPS Latitude/Longitude	
				Start	End
Item	Trim / Thin Trees			39.186739 °	39.186389 °
				-122.909436 °	-122.909821 °
DWR ID	DWR_NA0009_02_s_2013_9				
Comment Code					
T1 : Trim trees to at least five feet above ground level.					
Inspector Comment

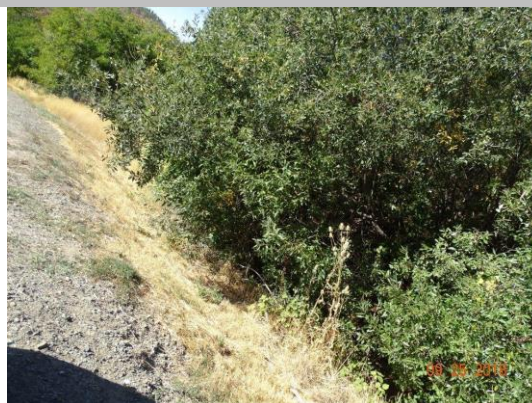
Photo 1 of 1 : FA_2018_NA0009_4_29_20181009_00050.jpg

View of the trees along the landside slope and toe.

LM Start	0.38	Rating **	M	Issue No.	29
LM End	0.38	Issue Type +	Ma	Location *	LS
Category	Earthen Levee			GPS Latitude/Longitude	
				Start	End
Item	Trim / Thin Trees			39.185208 °	39.185208 °
				-122.911065 °	-122.911065 °
DWR ID	DWR_NA0009_02_f_2018_29				
Comment Code					
T2 : Thin trees to allow visibility of the ground and room to flood fight.					
Inspector Comment					
Trim and thin the trees up at least 5 feet to allow visibility.

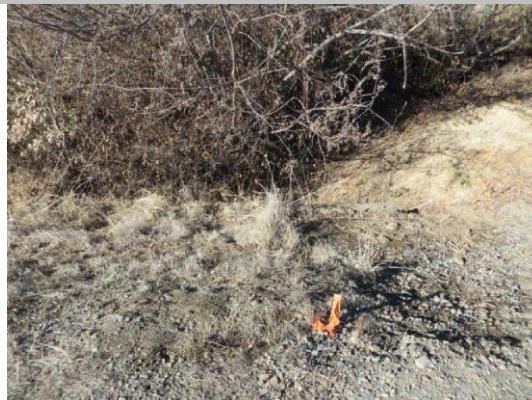
Photo 1 of 3 : UCIP_FA_2018_27192_50326.jpg

Pipe and concrete headwall at LS toe.

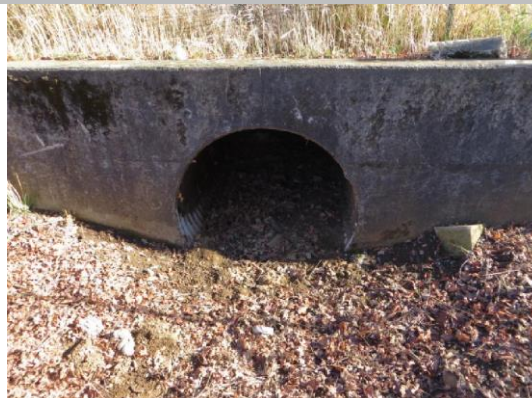
Photo 1 of 3 : UCIP_FA_2018_27199_50389.jpg

Concrete headwall on LS toe.

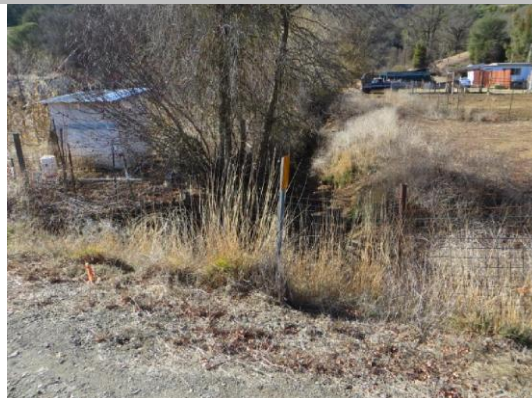
Photo 2 of 3 : UCIP_FA_2018_27199_50388.jpg

Pipe and concrete headwall on LS toe.

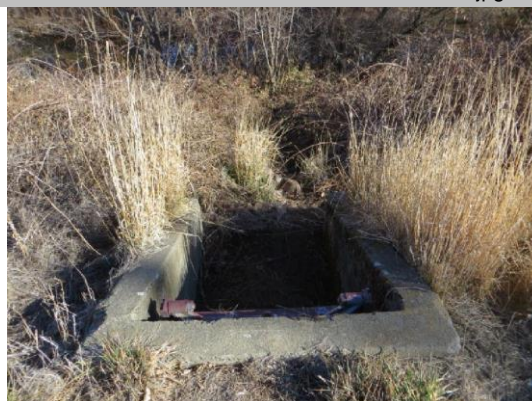
Photo 2 of 3 : UCIP_FA_2018_27208_50410.jpg

Flapgate and concrete headwall on WS berm.

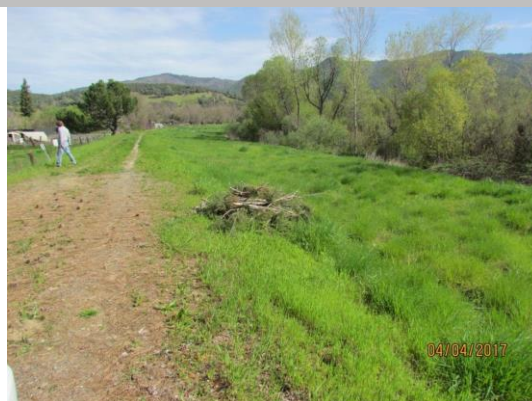
Photo 1 of 1 : FA_2018_NA0009_4_30_20180905_00012.jpg

View of the prunings along the waterside slope.

LM Start	0.56	Rating **	M	Issue No.	30
LM End	0.56	Issue Type +	Ma	Location *	WS
Category	Earthen Levee			GPS Latitude/Longitude	
				Start	End
Item	Encroachments			39.182940 °	39.182940 °
				-122.912142 °	-122.912142 °
DWR ID	DWR_NA0009_02_s_2017_30				
Comment Code					
PR : Prunings					
Inspector Comment					
Remove the prunings from the waterside slope.

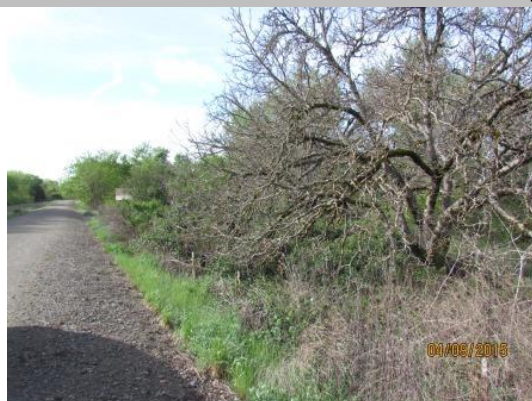
Photo 1 of 1 : FA_2018_NA0009_4_7_20180905_00005.jpg

View of the vegetation at the landside toe.

LM Start	0.97	Rating **	M	Issue No.	7
LM End	0.98	Issue Type +	Ma	Location *	LS
Category	Earthen Levee			GPS Latitude/Longitude	
				Start	End
Item	Vegetation			39.177218 °	39.176992 °
				-122.913673 °	-122.913642 °
DWR ID	DWR_NA0009_02_s_2012_7				
Comment Code					
V2 : Remove the wild growth other than native grasses from the levee slopes.					
Inspector Comment

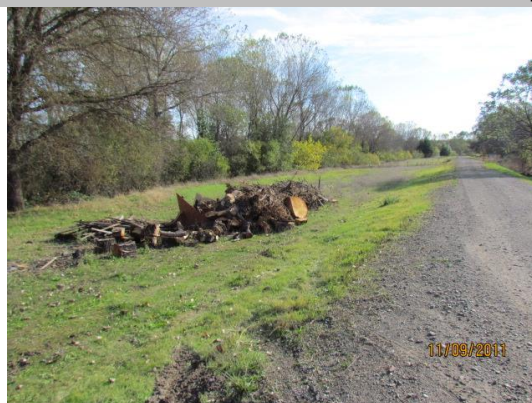
Photo 1 of 1 : FA_2018_NA0009_4_3_20180905_00003.jpg

View of the tree prunings on the W/S toe.

LM Start	0.99	Rating **	M	Issue No.	3
LM End	0.99	Issue Type +	Ma	Location *	WS
Category	Earthen Levee			GPS Latitude/Longitude	
				Start	End
Item	Encroachments			39.176835 °	39.176835 °
				-122.913558 °	-122.913558 °
DWR ID	DWR_NA0009_02_s_2012_3				
Comment Code					
TR : Tree or limb					
Inspector Comment

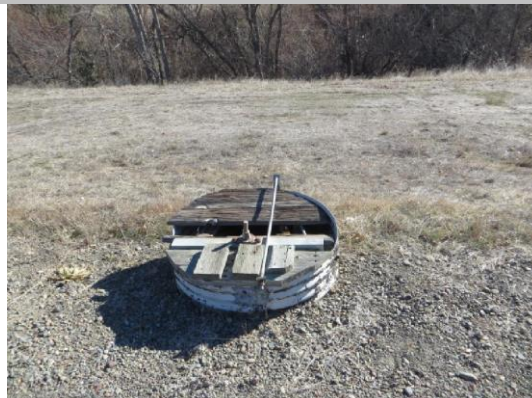
Photo 1 of 3 : UCIP_FA_2018_42994_51214.jpg

Slide gate in 44-inch CMP riser on WS shoulder.

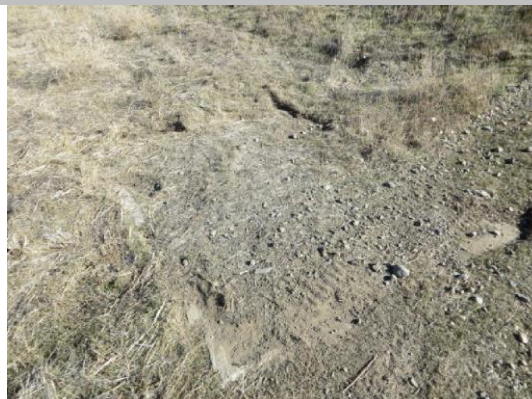
Photo 2 of 3 : UCIP_FA_2018_42994_51213.jpg

6'X8' concrete sump filled in with soil, visible at LS toe.

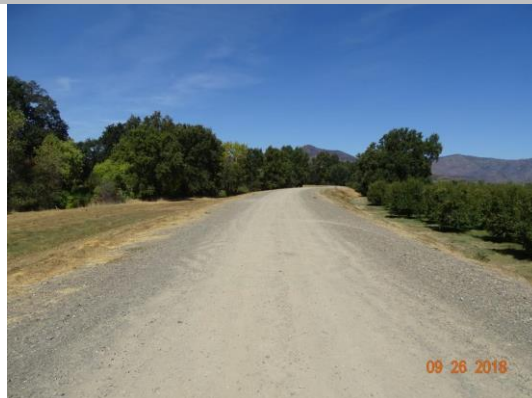
Photo 1 of 1 : FA_2018_NA0009_5_20_20181009_00042.jpg

LM Start	0.32	Rating **	A	Issue No.	20
LM End	0.32	Issue Type +	Ma	Location *	LS
Category	Earthen Levee			GPS Latitude/Longitude	
				Start	End
Item	Vegetation			39.151917 °	39.151917 °
				-122.917188 °	-122.917188 °
DWR ID	DWR_NA0009_03_f_2018_20				
Comment Code					
V1 : Control annual grass and weeds on the levee slopes and easements.					
Inspector Comment					
The vegetation was removed from both slopes.

View of no vegetation on both slopes.

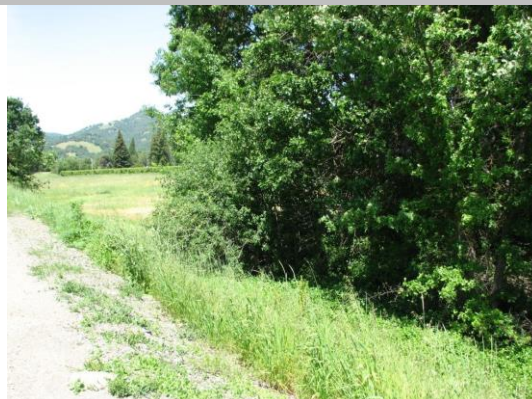
Photo 1 of 1 : FA_2018_NA0009_5_9_20180905_00001.jpg

LM Start	0.49	Rating **	M	Issue No.	9
LM End	0.49	Issue Type +	Ma	Location *	LS
Category	Earthen Levee			GPS Latitude/Longitude	
				Start	End
Item	Vegetation			39.154195°	39.154195°
				-122.918134°	-122.918134°
DWR ID	DWR_NA0009_03_s_2016_9				
Comment Code					
V2 : Remove the wild growth other than native grasses from the levee slopes.					
Inspector Comment

View of the overgrown trees and vegetation at the landside toe.

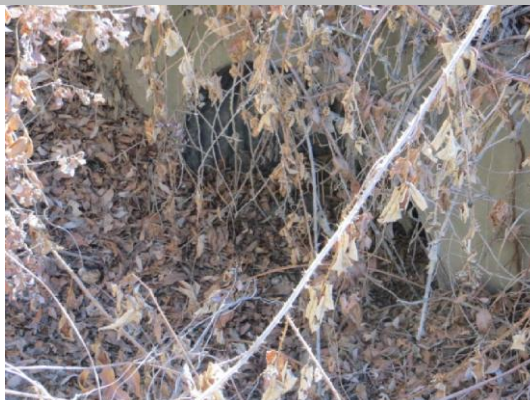
Photo 3 of 3 : UCIP_FA_2018_27894_51597.jpg

Comment Code						
Inspector Comment						
FS_ID:27894 DS_ID:21221 EP_NO: 11488 Repair Type: Non-Urgent Crossing Status: Found UCIP Comments: Concrete headwall on WS berm is being undermined. 2-foot of scour under headwall. FIELD_STRUCT_DESC: 42-inch corrugated metal drainage pipe through the levee, 16.5 feet below the crown. Flap gate on the waterside (WS) end. Concrete headwalls on both ends. (42-inch pipe [HLM 0.94] retained under Automatic Board Order (ABO) issued as Permit No. 11488, 1975 - Robert F. and Mary E. Wheeler). [Additional Reference(s): DWR Levee Log, 2005. USACE Sacramento O&M Manual 506.2, August 1961, (HLM 0.94)]. FS Date: 1/22/2014

Concrete headwall on LS toe.

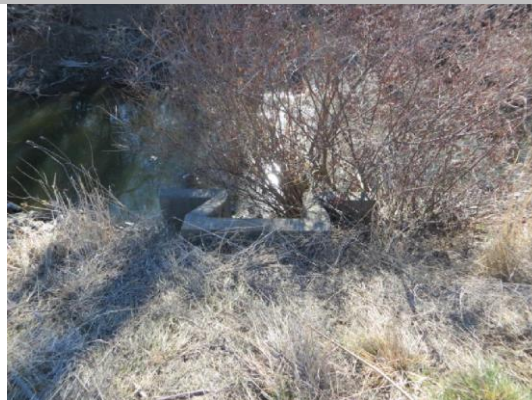
Photo 1 of 3 : UCIP_FA_2018_27943_51642.jpg

Concrete Headwall on WS berm.

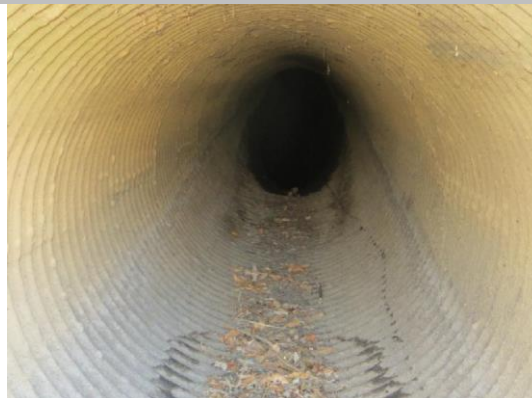
Photo 2 of 3 : UCIP_FA_2018_27963_51661.jpg

Pipe on LS toe.

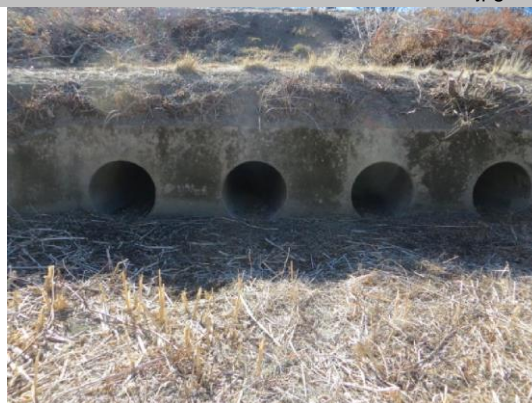
Photo 1 of 3 : UCIP_FA_2018_27964_51665.jpg

Pipe and headdwall on LS toe.

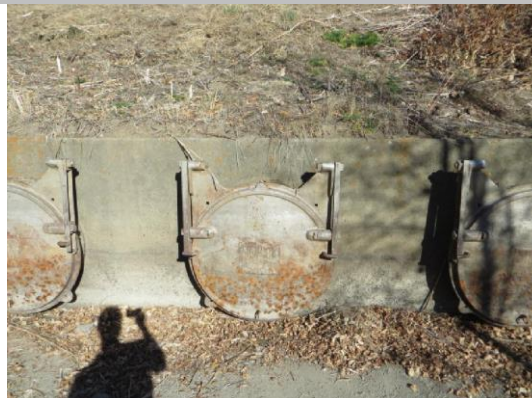
Photo 3 of 3 : UCIP_FA_2018_27964_51663.jpg

Flapgate and headwall on WS toe.

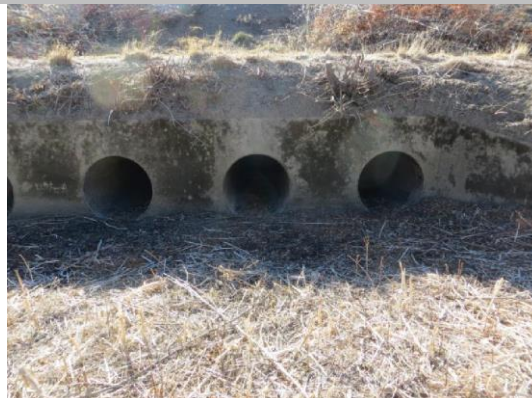
Photo 1 of 3 : UCIP_FA_2018_27965_51668.jpg

Pipe and concrete headwall on LS toe.

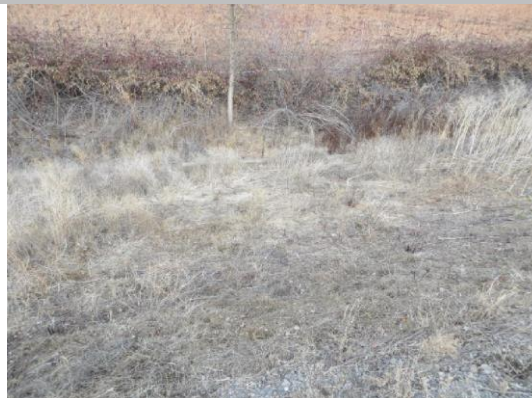
Photo 1 of 3 : UCIP_FA_2018_26947_49793.jpg

Concrete headwall visible on LS toe.

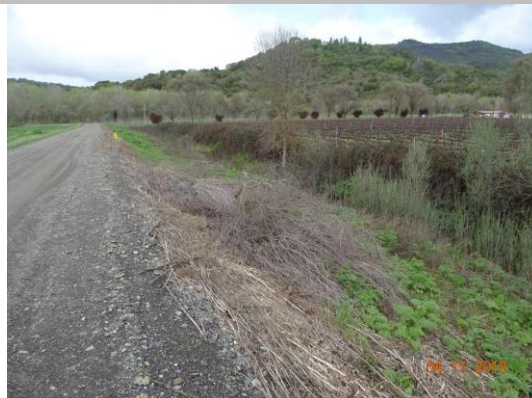
Photo 1 of 2 : FA_2018_NA0009_6_17_20180905_00007.jpg

View of the tree along the landside slope.

LM Start	0.15	Rating **	M	Issue No.	17
LM End	0.15	Issue Type +	Ma	Location *	LS
Category	Earthen Levee			GPS Latitude/Longitude	
				Start	End
Item	Encroachments			39.176420 °	39.176420 °
				-122.909693 °	-122.909693 °
DWR ID	DWR_NA0009_04_s_2018_17				
Comment Code					
TR : Tree or limb					
Inspector Comment					
Removed the trees from the landside slope.

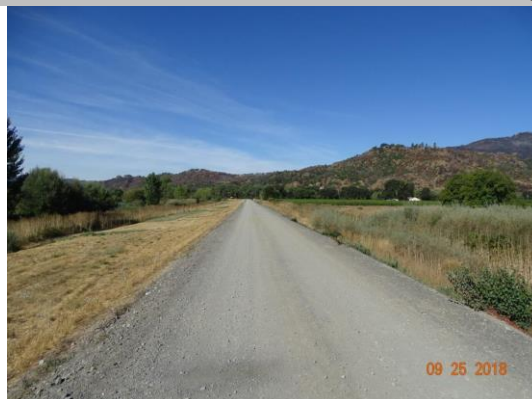
Photo 1 of 1 : FA_2018_NA0009_6_9_20181009_00023.jpg

LM Start	0.38	Rating **	A	Issue No.	9
LM End	0.38	Issue Type +	Ma	Location *	WS
Category	Earthen Levee			GPS Latitude/Longitude	
				Start	End
Item	Vegetation			39.176397 °	39.176397 °
				-122.905395 °	-122.905395 °
DWR ID	DWR_NA0009_04_f_2018_9				
Comment Code					
V1 : Control annual grass and weeds on the levee slopes and easements.					
Inspector Comment					
The vegetation was removed from waterside slopes.

View of no vegetation on waterside slopes.

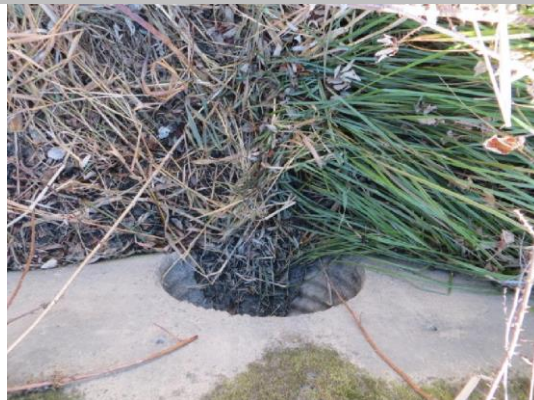
Photo 2 of 3 : UCIP_FA_2018_53332_49753.jpg

Pipe and concrete headwall visible in drainage channel on LS toe.

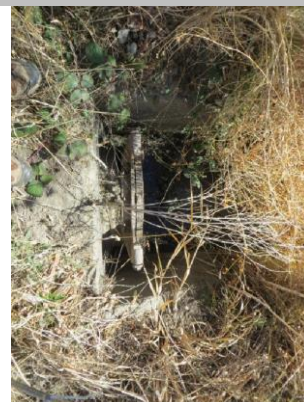
Photo 3 of 3 : UCIP_FA_2018_53332_49752.jpg

Flapgate at concrete headwall on WS toe.

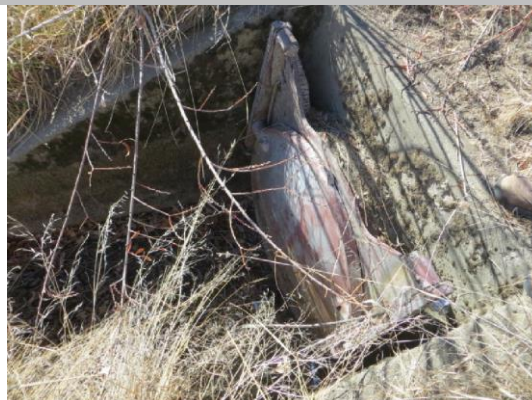
Photo 3 of 3 : UCIP_FA_2018_26924_49760.jpg

Concrete headwall visible off WS berm.

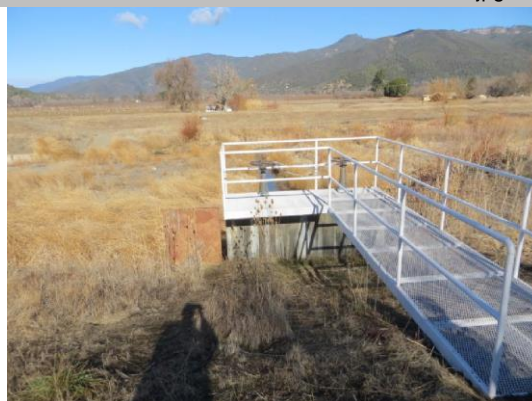
Photo 1 of 3 : UCIP_FA_2018_26891_49682.jpg

Slide gate on steel walkway at WS toe.

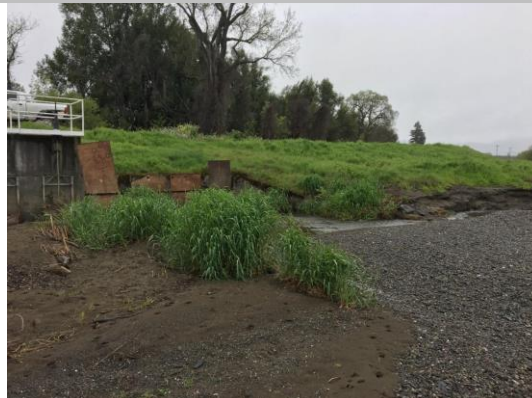
LM Start	0.32	Rating **	A/W	Issue No.	13					
LM End	0.32	Issue Type +	Ma	Location *						
Category	Supplemental		GPS Latitude/Longitude							
			Start	End						
Item	2017 Storm Damage		39.177150 °	39.177150 °						
			-122.899111 °	-122.899111 °						
DWR ID	DWR_NA0009_05_f_2017_13									
Comment Code										
Inspector Comment										
Levee Evaluation Comments Description: Site ID No:19 Site Designation:LCWPD-01 Repair Type: Erosion Rating:Area of Concern Field Date:6/5/2017 Notes: Erosion exists between a small weir and diversion pipes.
